**DRY STONE MASONRY CULVERT RESTORATION**

**Research Report**  
**KTC-07-13/KH 55-07-1F**  
**Dry Stone Masonry Culvert Restoration**

<b>16. Abstract</b> A damaged dry stone masonry culvert on KY 1268 Jessamine County was restored by the Kentucky Transportation Cabinet. The work was performed by the Dry Stone Conservancy, a non-profit agency promoting dry stone masonry. The work included replacement of a retaining wall and widening of the culvert. The project also included a partnering effort to improve the skills of local stone masons.					
<b>17. Key Words</b> Culvert, Dry Stone, Historic Structure, Masonry, Restoration				<b>18. Distribution Statement</b> Unlimited with the approval of the Kentucky Transportation Cabinet	
<b>19. Security Classif. (of this report)</b> Unclassified		<b>20. Security Classif. (of this page)</b> Unclassified		<b>21. No. of Pages</b> 22	<b>22. Price</b>

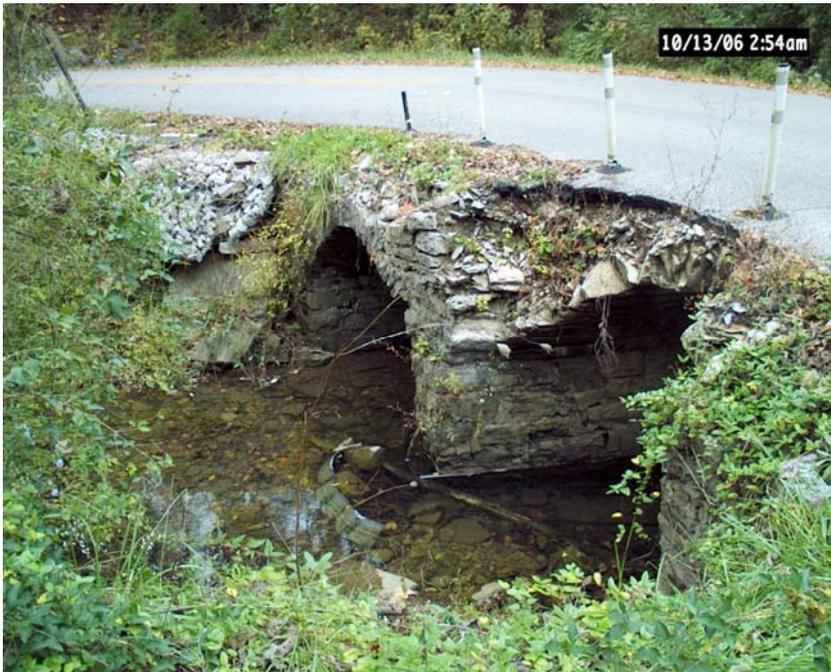
In October 2006, the Kentucky Transportation Cabinet (KYTC) awarded a contract to the Kentucky Transportation Center (KTC) for repairing a stone culvert and retaining wall located on KY 1268 in Jessamine County, Ky. The culvert had sustained considerable damage when a large truck ran off the roadway and into the south side of the culvert (Figure 1). The original culvert employed a mix of wet and dry stone construction.

Figure 1. View of the damaged double-barrel stone culvert and the gabion retaining wall prior to onset of the project. *(Picture provided by the Dry Stone Conservancy)*

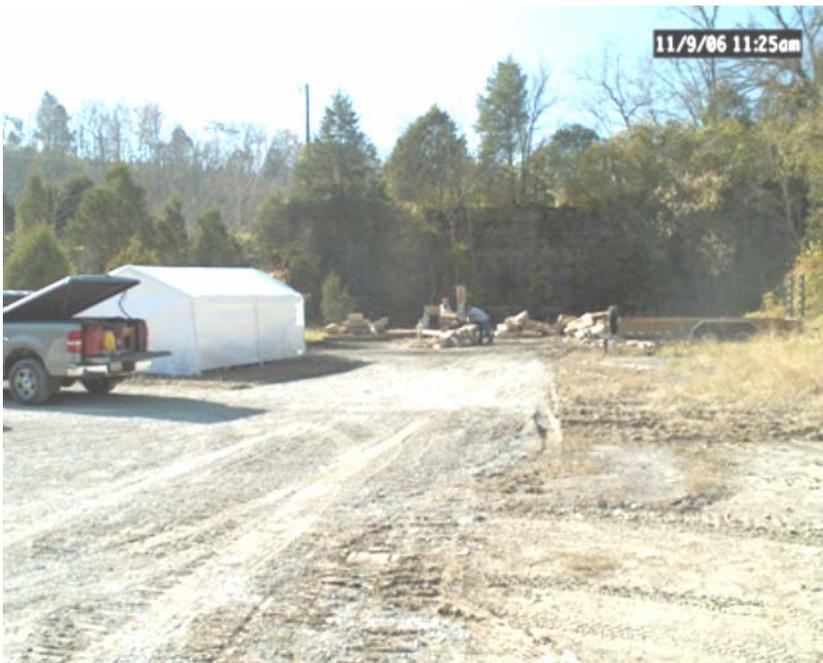
The DSC crew began by establishing a staging and preparation area in an abandoned quarry located adjacent to the culvert. Work performed in this area centered on preparation (shaping & sizing) of stones used as the construction material in the culvert and retaining wall. Large stone slabs were obtained from a nearby source and delivered to the staging area. Although those slabs did not come from the abandoned quarry (that probably provided stone for the existing culvert) they were from the same rock strata providing a visual/structural match with the existing culvert stones (Figure 2).

Figure 2. The DSC used abandoned quarry to store, cut and dress stones for the rebuilding of the culvert.

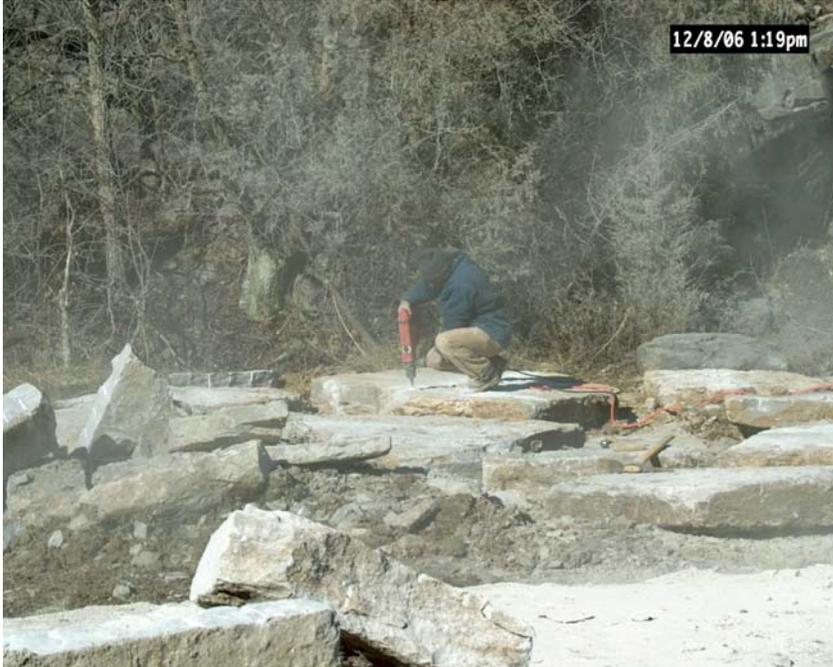
The stone slabs were split into strips by drilling and use a technique termed “plugs-and-feathers”. Masons would drill holes 6” to 8” apart penetrating to a depth of about 2/3 of the slab thickness (Figure 3). Then, they would place feathers into the holes and incrementally drive plugs (wedges) in the holes, hammering the plugs until the rock slabs would split into smaller strips (Figure 4). Those rough-cut pieces were taken to a *Mason-50 Hydraulic Rock Breaker* and broken into near-final-dimension sizes (Figure 5). The stones were finished (dressed) using manual and powered chisels that used compressed air (Figure 6).

Figure 3. Large stone slabs were obtained for use in the culvert and retaining wall. This picture shows a mason drilling holes in a stone slab.

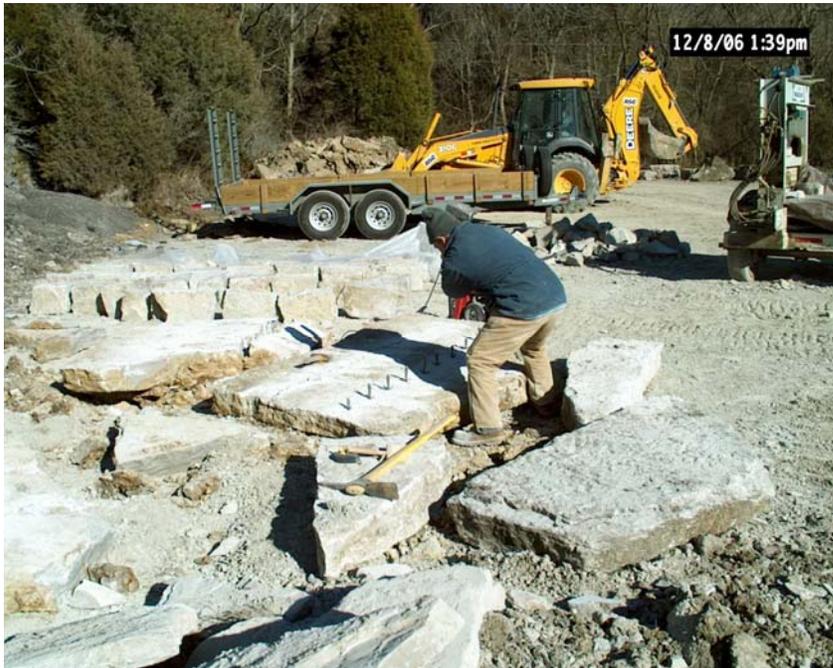
Figure 4. Masons hammered plugs (wedges) into the holes drilled in the stone slabs to split them into manageable sizes.

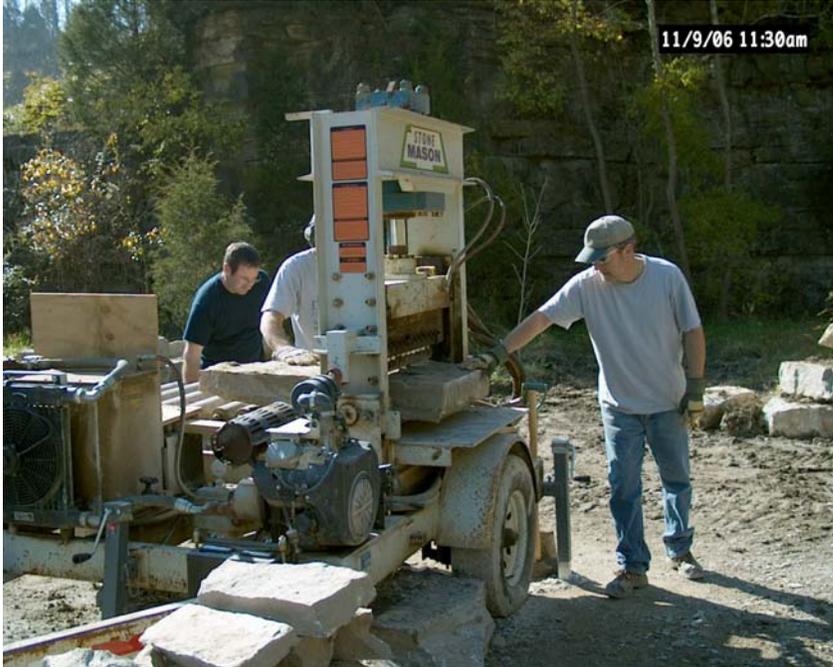
Figure 5. Masons used a *Mason-50 Hydraulic Rock Breaker* to break rough-cut pieces from the slabs into smaller ones approximating their final dimensions.

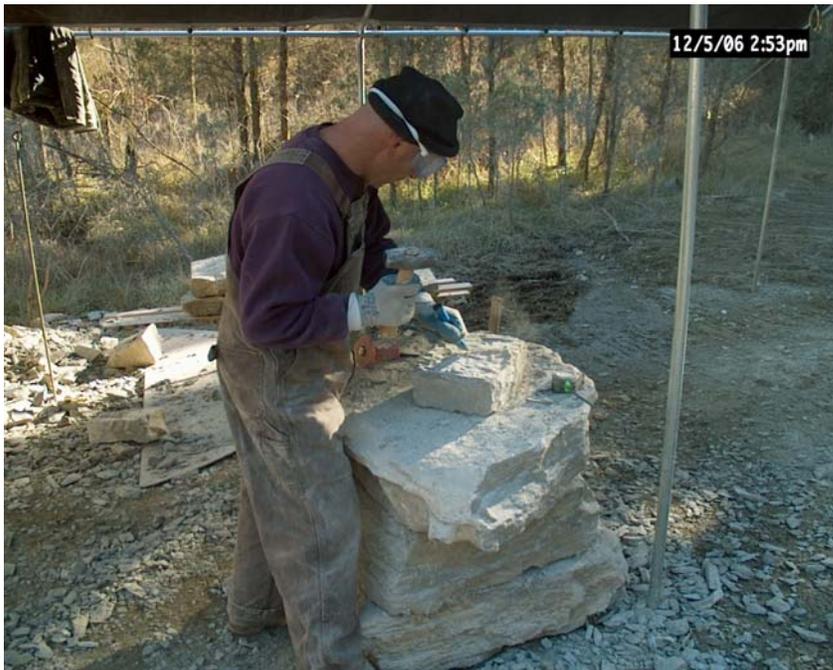
Figure 6. Once the stone pieces had been roughly cut, masons chiseled them to the final size and shape. Stones used for the culvert barrel arches had tapers chiseled on two opposing faces.

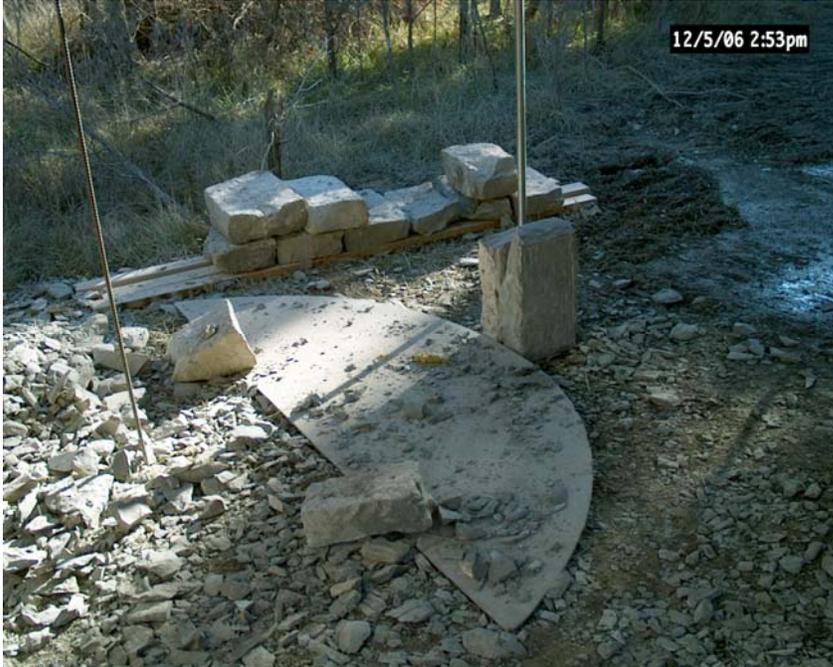
The smaller stones used to form the culvert barrel arches (vaults) were laid out on the ground in courses of the same thickness. Then they were tapered by chiseling to fit a template of the culvert barrel (Figure 7). The surfaces of the tapered stones had a rough finish to promote friction between mating surfaces and thereby inhibit sliding. Waste generated during stone cutting and tapering was saved to be used for packing and fill material inside the culvert. Larger blocks were used for the pier and abutments.

Figure 7. As the vault stones were shaped, they were placed around a arch template (the semi-circle plate) to assure the proper taper and fit.

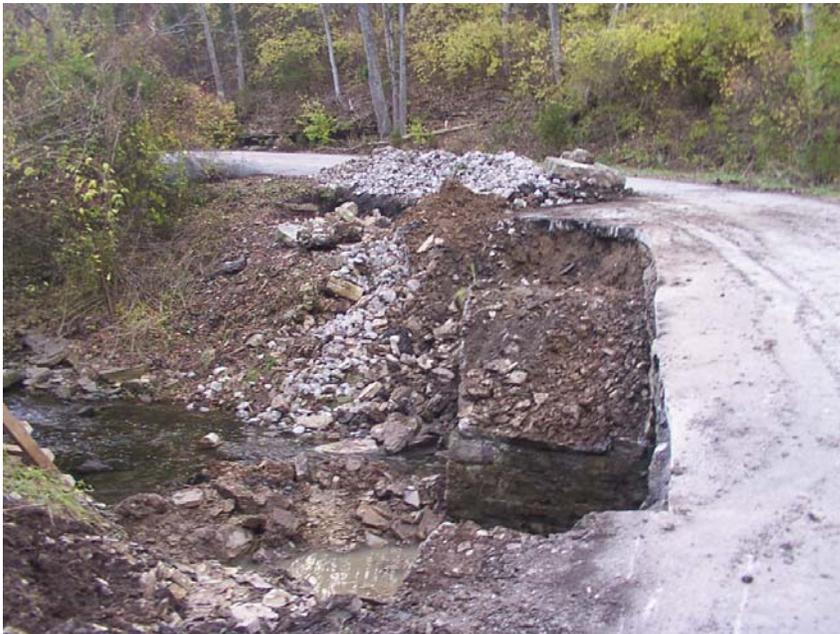
The mortared section of the culvert was carefully dismantled down to structurally sound existing stonework or stable footing just below grade (Figure 8). Rotten, severely weathered and mortar-encased stones were discarded.

Figure 8. View of site preparation work. The north vault was uncovered and the south vault and gabion retaining wall were dismantled.

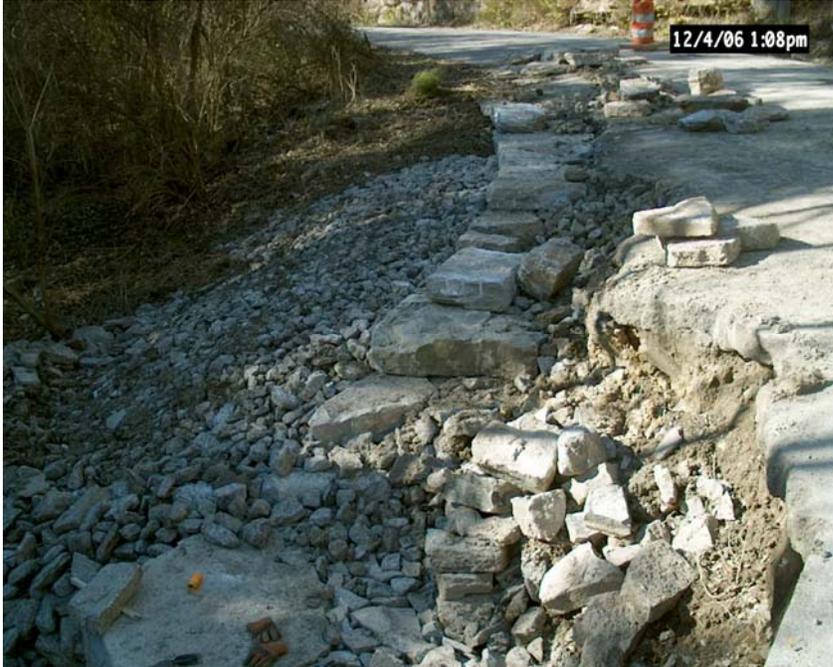
Once the stone preparation began at the staging site, work started on dismantling the gabion retaining wall. It was subsequently replaced with a dry laid stone retaining wall along the existing alignment (Figure 9). The replacement wall had a 1:6 (horizontal to vertical) batter that transitioned into the culvert abutment. Tie stones were incorporated at regular intervals to tie the wall face to the core packing behind it. A stepped foundation with a 4-inch projecting foundation course was installed followed by a drystone cover course.

Figure 9. Work on the retaining wall that replaced the gabions at the north end of the culvert.

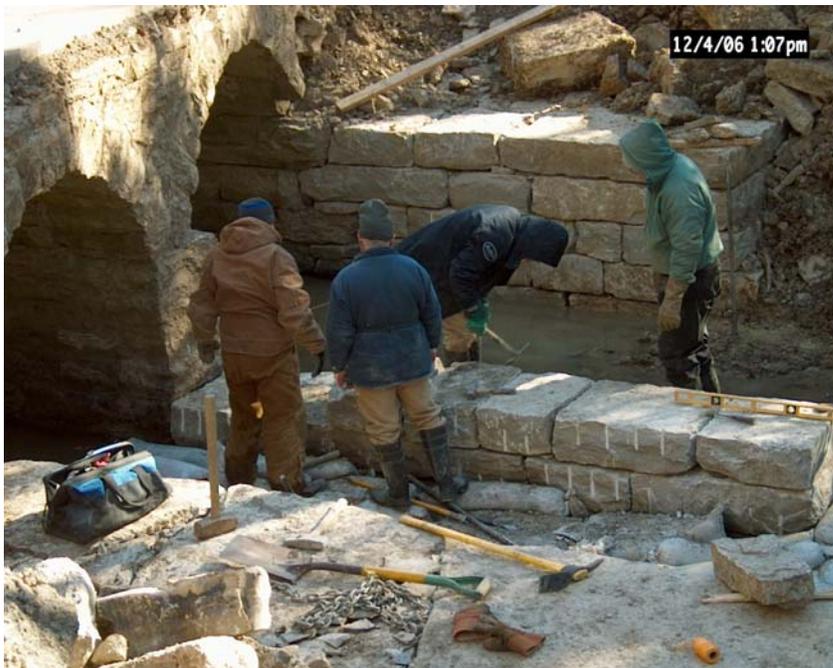
Larger stones blocks were prepared and placed at the base of the culvert to extend the width of the culvert pier and abutments (Figure 10). With the pier and abutments extended, wooden falsework (centering) for the vaults (arches, barrels) were built and placed in alignment with the existing culvert vaults (Figure 11). Masons proceeded to lay and dress the stones forming the arches at precise angles around the falsework (Figures 12-16). This work was complicated slightly due to the different sizes of the two barrels. The north barrel had an arch radius of 56 inches and a span of 101 inches and the south barrel had an arch radius of 49 inches and a span of 92 inches.

Figure 10. The masons placed the newly cut stone block to re-form the demolished portions of the culvert center pier & abutments and to extend the culvert.

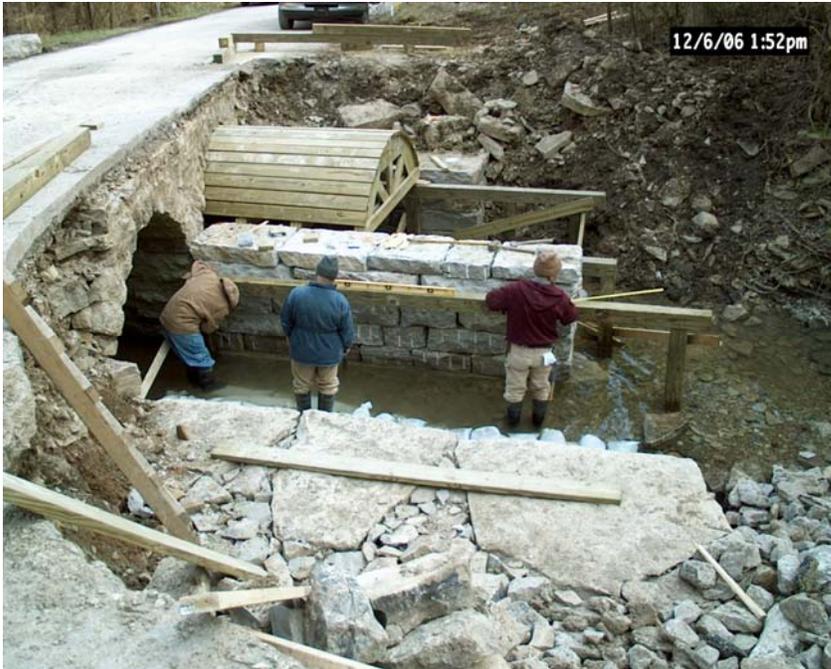
Figure 11. The DSC finished construction of the falsework on the south vault and began installing falsework for the north vault.

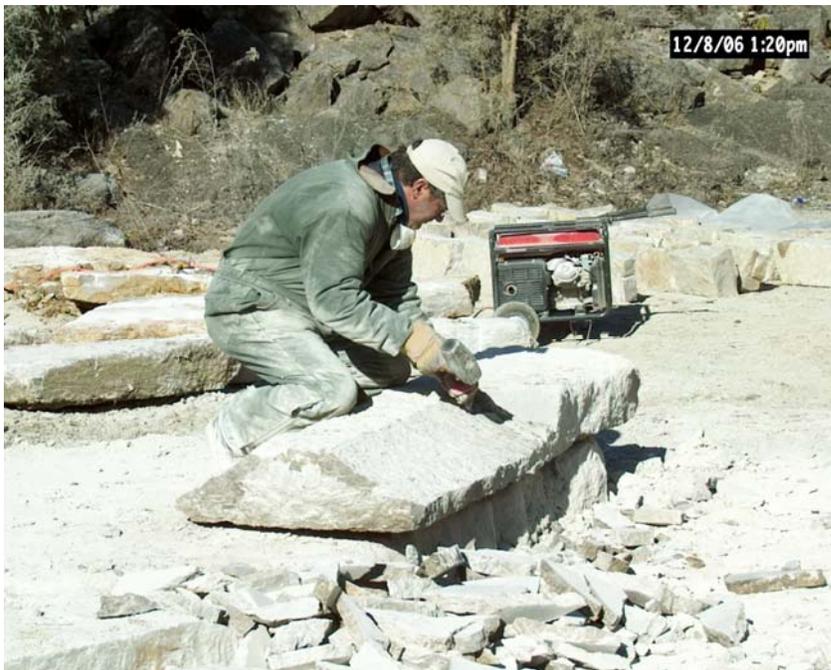
Figure 12. A mason is shown preparing a “springer” stone to cap the center pier. These stones formed the base for the vaults rising from the pier.

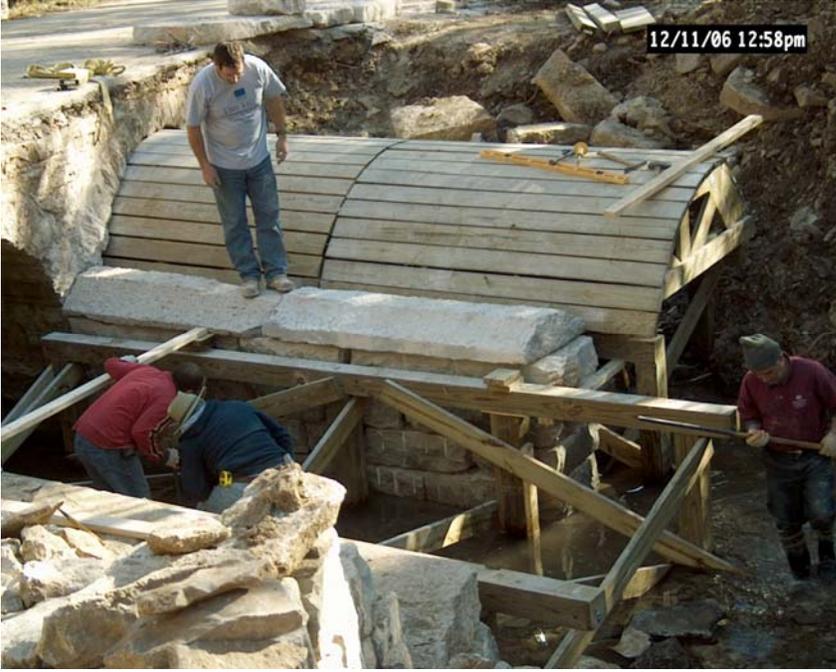
Figure 13. The center pier “springer” stones are shown after placement.

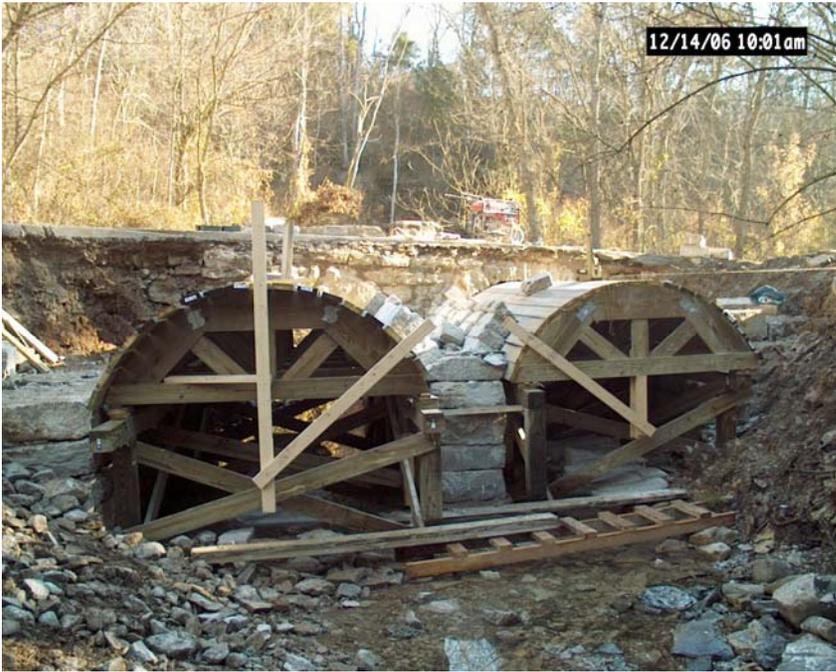
Figure 14. This view shows the abutments and pier looking into the west side of the culvert. Note that some smaller vault stones having been placed around the falsework.

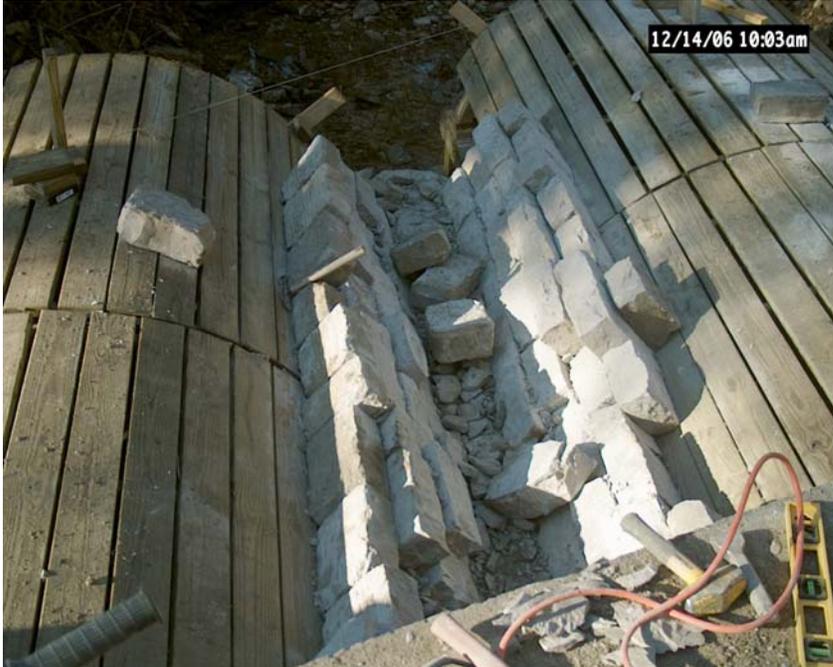
Figure 15. The smaller stones, also known as “voussoir” stones, were laid in courses with all joints broken. Each “voussoir” stone received a final dressing to fit properly.

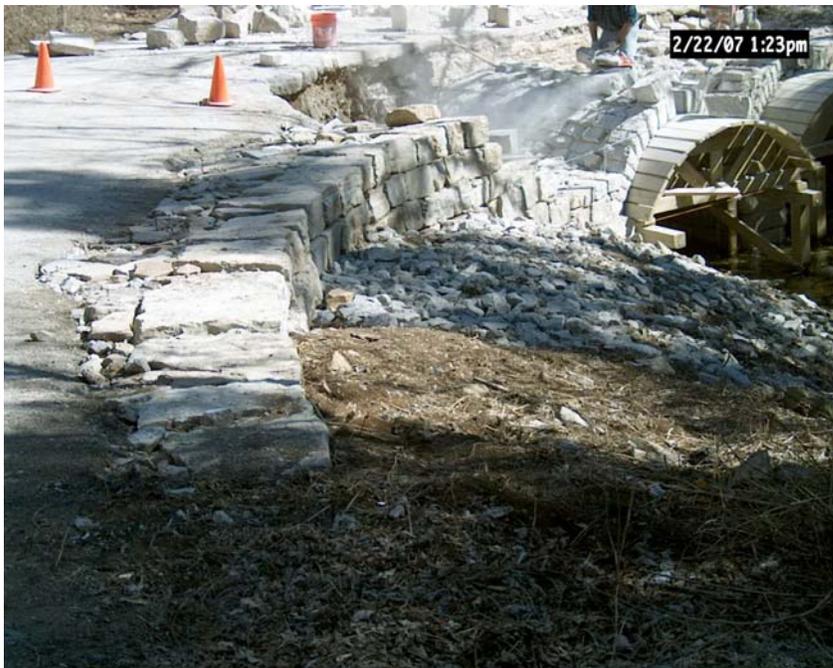
Figure 16. This view shows the dry stone retaining wall which is nearly completed. In the background, a mason is dressing the top of the center (keystone) course of the vault falsework.

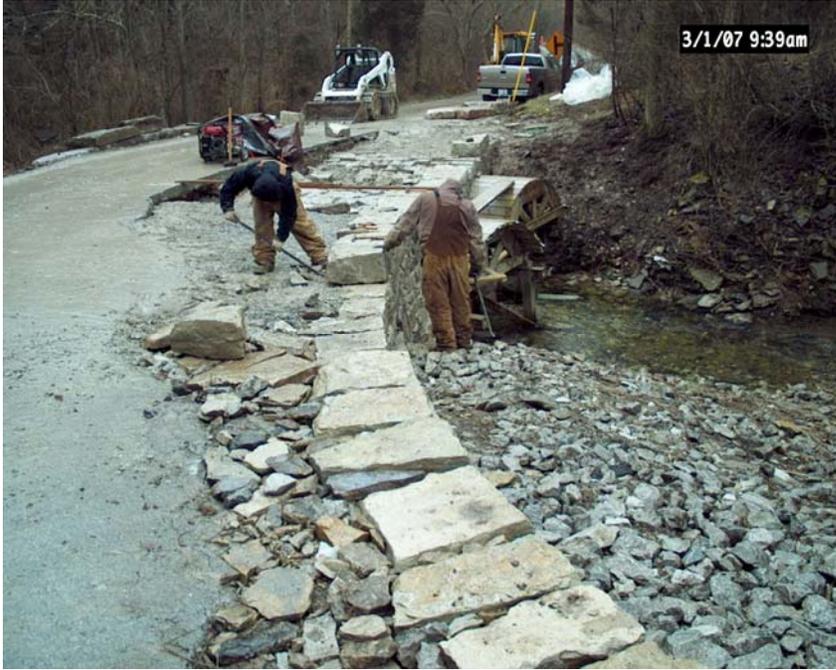
As work progressed on the culvert, the barrel arches and culvert walls were completed. Wall capstones were subsequently placed with their tops level to the proposed road grade (Figure 17). Thick stone slabs are cut, shaped and dressed and set atop the culvert vaults to be used as brush curbs. Two of those curb stones were from the original culvert. They had been pushed into the stream during the crash and were retrieved for reuse. The space created by the vaults and walls was carefully hand packed and filled with stone rubble generated during stone preparation and topped with a gravel road base in preparation for asphalt (Figure 18). Large stone slabs were temporarily placed over the culvert vaults to help seat them (Figure 19). Once the culvert stone work had been completed (Figure 20), the falsework inside the culvert vaults was removed and carried away to be dismantled (Figures 21 and 23). Inspection inside the culvert vaults showed that the stonework in the vaults was properly consolidated (Figures 22 and 24).

Figure 17. Capstones were placed with tops level with proposed road grade (after paving).

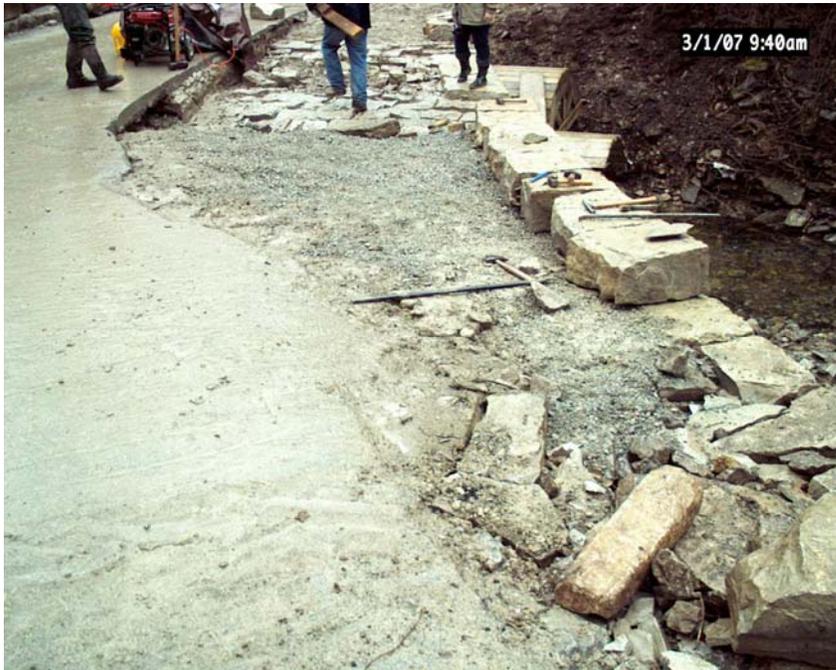
Figure 18. Packing and road base material was added behind the culvert wall face level to the bottom of the capstones.

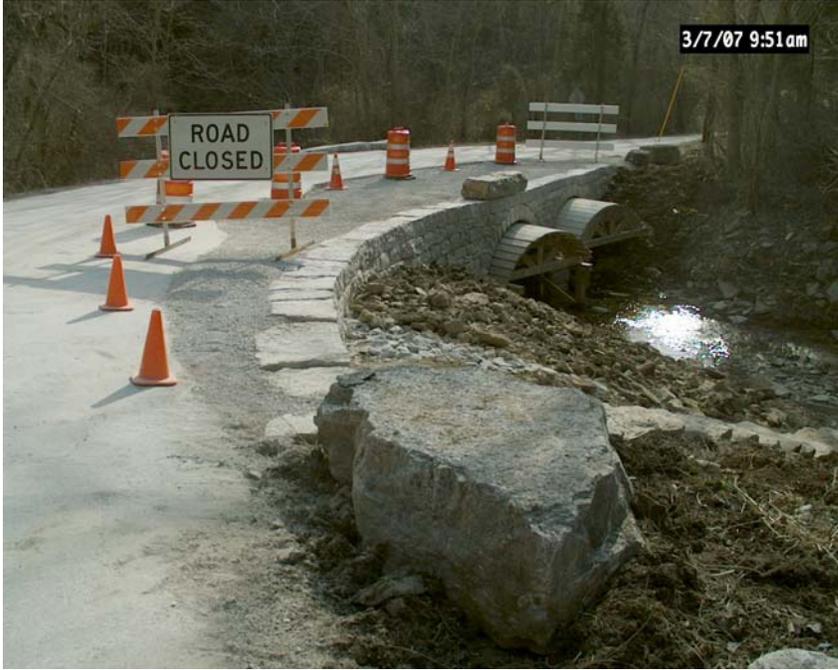
Figure 19. A view of the project before the falsework was removed.

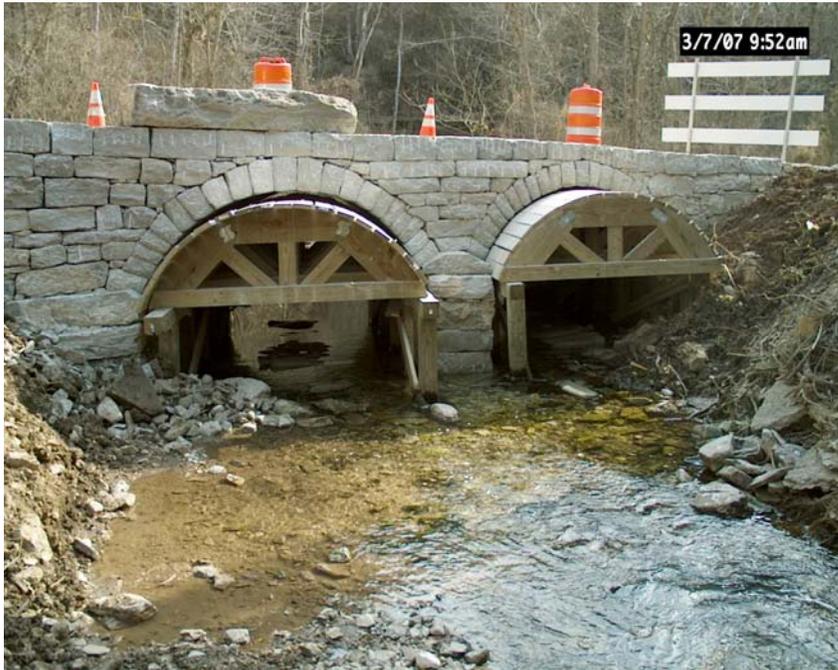
Figure 20. A view of the completed stone work looking into the west face of the culvert..

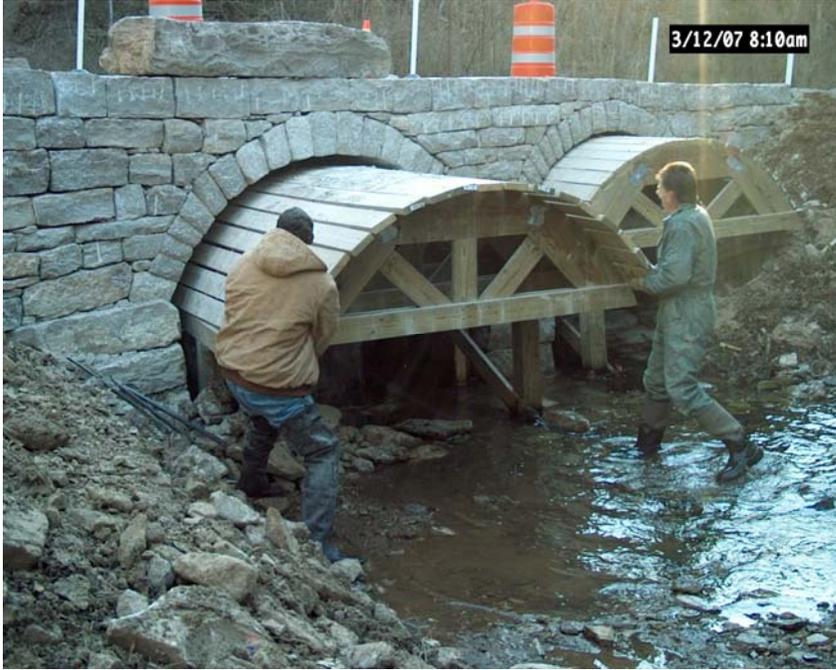
Figure 21. The masons removed the falsework from the north vault.

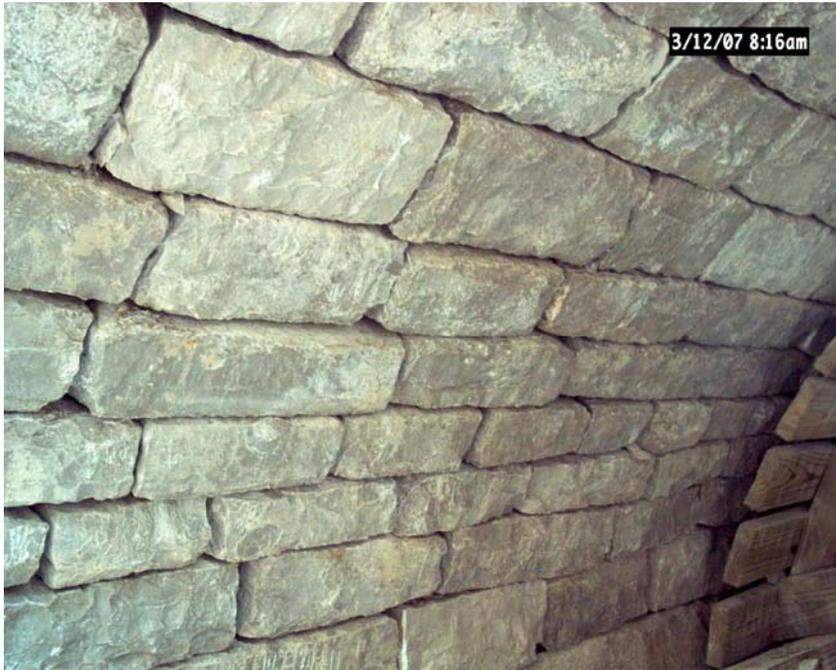
Figure 22. This view shows the completed stone work in the north vault.

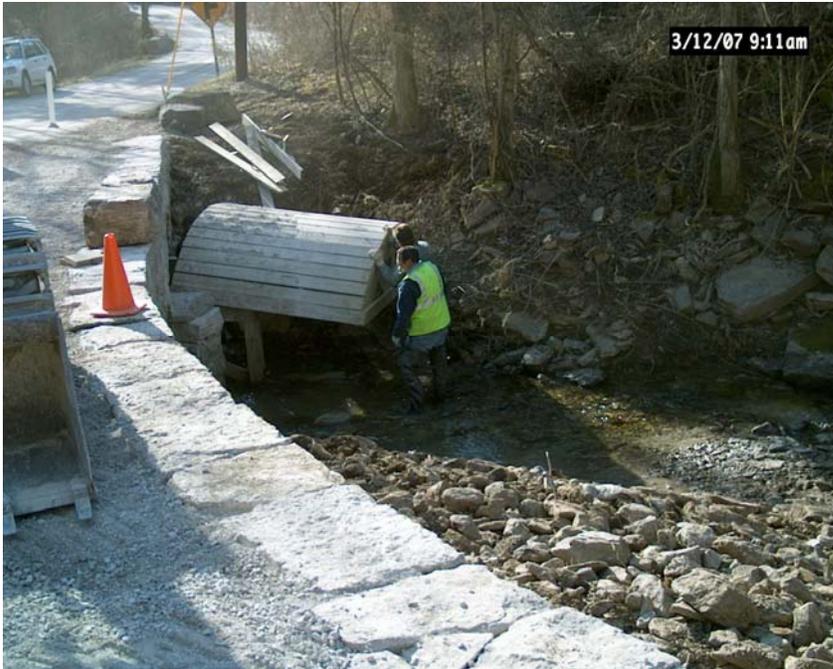
Figure 23. This photo shows the masons removing the falsework from the south vault.

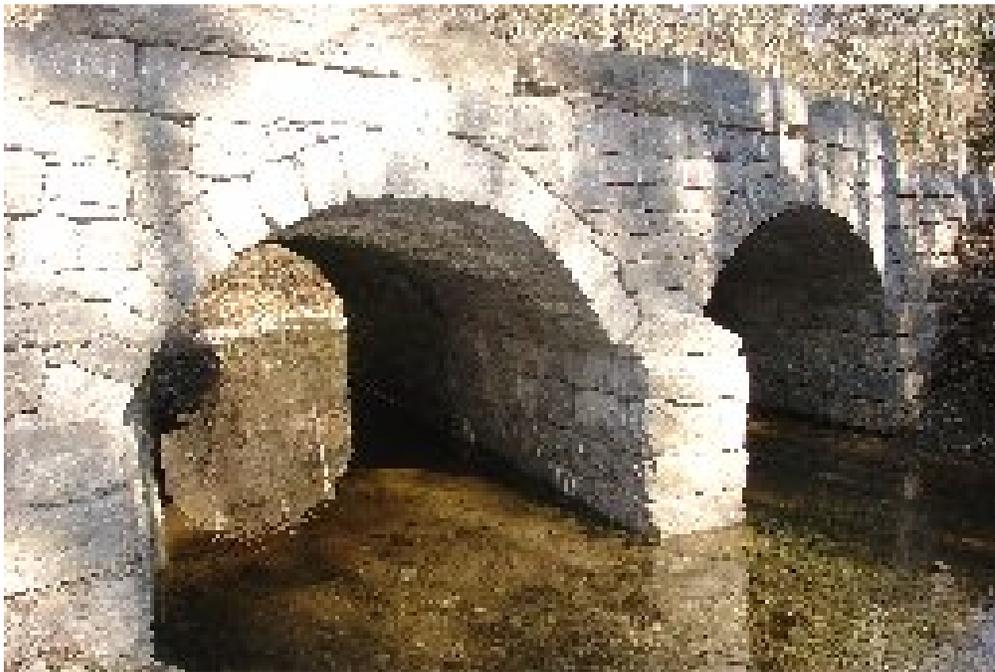
Figure 24. A view of the restored culvert. *(Picture provided by the Dry Stone Conservancy)*

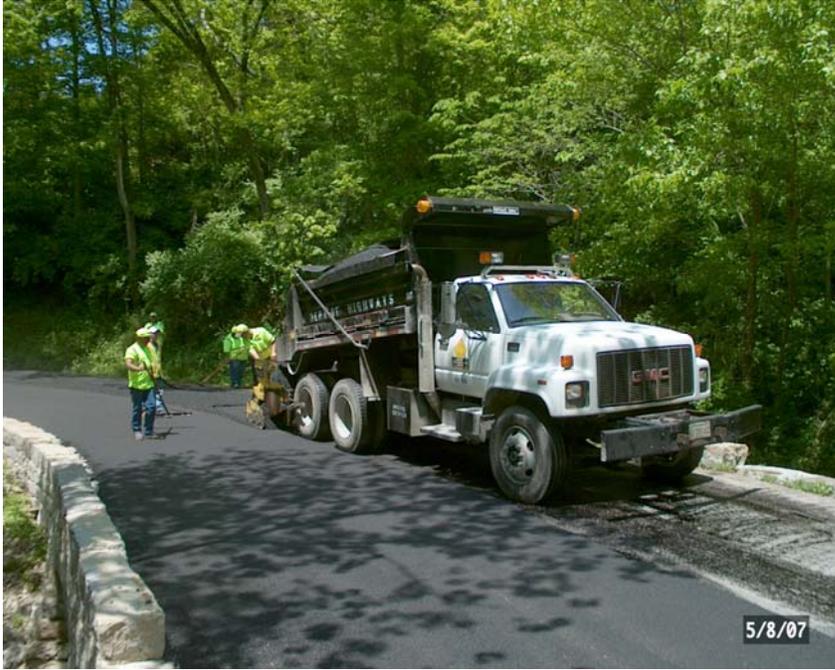
One lane of the roadway that was not damaged was re-opened to the public when the stonework was completed during the first week of March. The abandoned quarry was returned to its original state prior to the DSC leaving the job site. Paving work in the previously damaged area over the culvert (from the wall capstones to the original road) was completed on May 8, 2007 (Figures 25 and 26)

Figure 25. Paving work on the culvert deck.

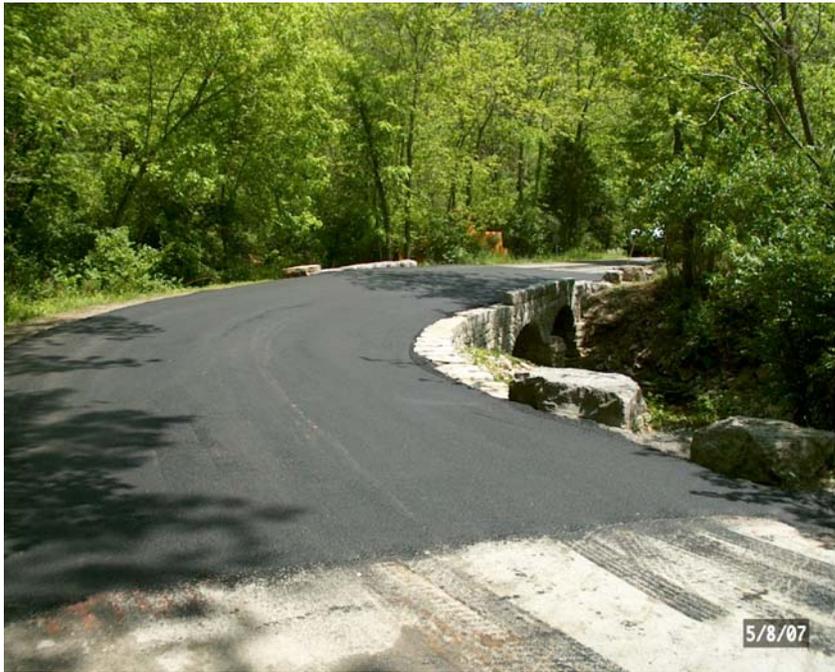
Figure 26. The completed project on May 8, 2007 (except for paint striping on the roadway).
